## ADVISORY CIRCULAR 43-16A

# AVIATION MAINTENANCE ALERTS

ALERT  
NUMBER  
298

MAY  
2003

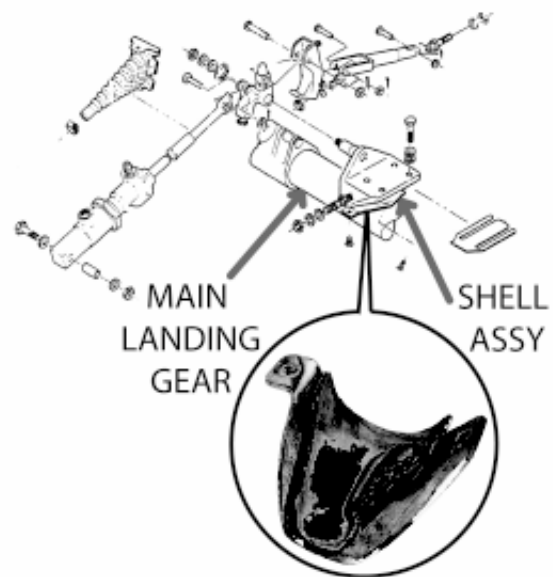
During an inspection, the technician discovered the left and right main landing gear down-lock support shell bumpers (P/N 1241630-7 left, and P/N 1241630-8 right) had debonded. The bumper edges had curled over preventing the main gear strut from making full-down travel. This condition prevented the main landing gears from properly locking. (Refer to the illustration.)

The submitter believes the composition of the shell bumper material does not have good bonding qualities.

Part total time-137 hours.

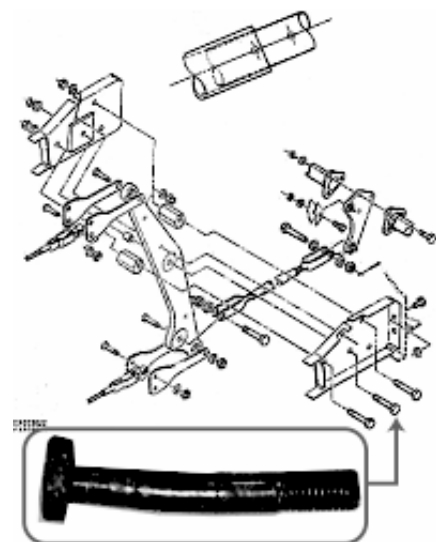
**Cessna; Model 340; Elevator Control System; ATA 2730**

Five recently processed Malfunction or Defect (M or D) reports cited failure of the elevator bellcrank (P/N 5360801-4) pivot bolt (P/N AN4-14). According to the submitter, one of the five aircraft's elevator bellcrank bolts was broken and the others were bent. He stated the only way to check the condition of the bolt is to loosen the elevator cables and remove the bolt. One bolt was so bent that he had to remove a skin panel on the side of the aircraft in order to drive the bolt out. (Refer to the illustration.)

The submitter feels a few items may be contributing to this defect other than the part's total time. Excess elevator movement may occur when the aircraft sits on the ramp during windy conditions. There are no spacers supporting the sides of the bearing in the center pivot of the bellcrank, which allows side movement and may be a contributing factor to this defect.

The submitter stated the Maintenance Manual does show a spacer between the bellcrank center pivot point, but the Illustrated Parts Catalog (IPC) does not.

Part total time averaged-6,256 hours.

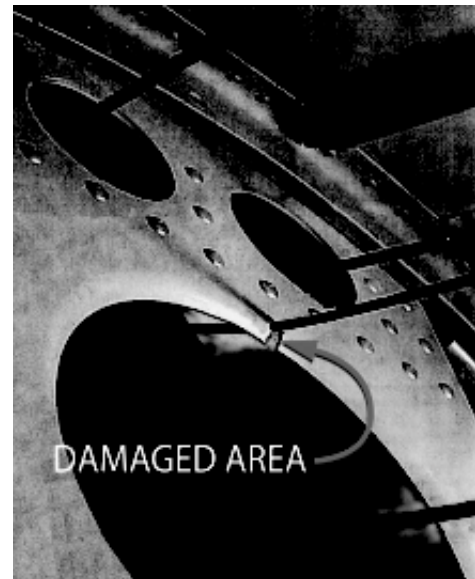
**LEARJET****Learjet; Model 31; Elevator Control Cable; ATA 2730**

During an inspection the technician discovered the left aft elevator control cable (P/N 2300003171) was misrouted and cutting into the structure rib at frame 29 station 541.57. (Refer to the illustration.)

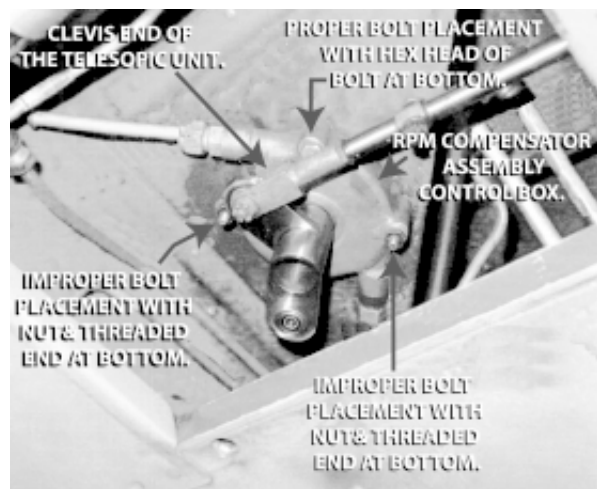
A post-incident investigation revealed that the four hex head bolts, which secure the RPM compensator assembly control box into the cabin ceiling, had been installed such that each bolt head was at the top of the control box with each threaded bolt end extruding downward through the control box bolt retaining ears. The threaded (nut) ends of all four bolts were observed extending out the bottom of the control box retaining holes such that the threaded end of each bolt faced down, and at least one bolt end was found to interfere with the movement of the RPM compensator telescopic unit clevis.

The Technical Order provided no guidance as to the proper orientation (up or down) for the bolts upon installation and no caution that reverse installation could lead to collective jamming.

Part total time unknown.
